**Flood Control Project Maintenance
Levee Inspections**
LMA District Cover Sheet
Spring 2018 Levee Inspection Results

Reclamation District No. 0070 Meridian

Spring 2018 Levee Inspection Results

Waterway			Bank	Unit Miles
Unit No. 01 Sutter Bypass			Right	7.92
	Spring (March - May)	Summer (June - August)	(September - November) Fall	Winter (December - February)
Unit Maintenance Rating (Fall Only)				
Date of Inspection	3/15/2018 - 3/15/2018			
DWR Inspector	Bob Duffey			
Accompanied By	Andy Duffey

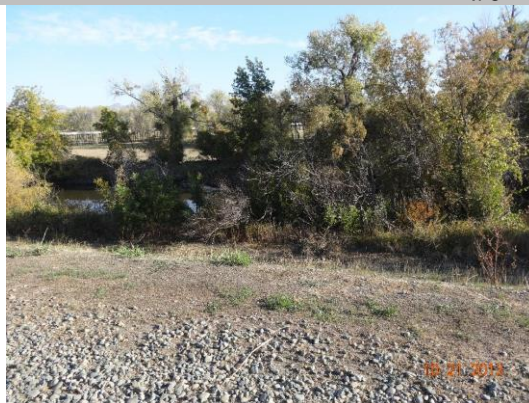
Photo 1 of 3 : UCIP_SP_2018_23463_40622.jpg

View of waterward side--no markers visible.

Comment Code					
Inspector Comment					
FS_ID:23463 DS_ID:21347 EP_NO: 3804 Repair Type: Non-Urgent Crossing Status: Indicator Found UCIP Comments: Unable to confirm if the indicators that were found in the field correspond to this crossing. Will need to contact PG&E to confirm location of crossing. Photos will need to be updated if the photos attach do not correspond to this crossing. This crossing is referenced in the USACE Periodic Inspection as item USACE_CESPK_MRD1_2012_p_0304 for 12 inch gas pipe. Coordinates between DWR UCIP and USACE PI are approximately 630 feet apart. FIELD_STRUCT_DESC: 12-inch coated steel natural gas pipeline through the levee, 3.6 feet below the crown. Concrete cutoff wall around the pipe at the center of the levee. Marker sign on the waterside (WS) shoulder. Rock revetment on the WS slope. (Plans for installation of a 12-inch gas collecting line through the levee authorized under Permit No. 3804, 1961 - Pacific Gas and Electric Company [PG&E]). [Additional Reference(s): DWR Levee Log, 2007]. FS Date: 10/21/2013

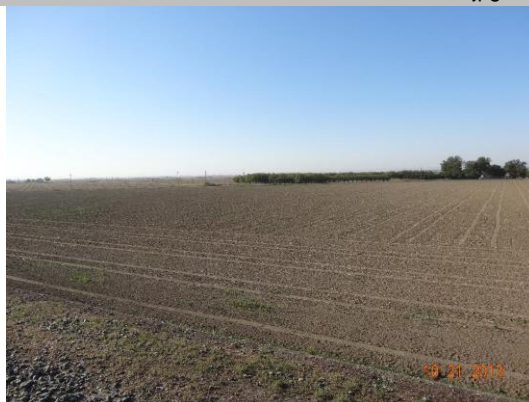
Photo 2 of 3 : UCIP_SP_2018_23463_40621.jpg

View of landward side where gas line markers are visible approximately 900 feet from levee.

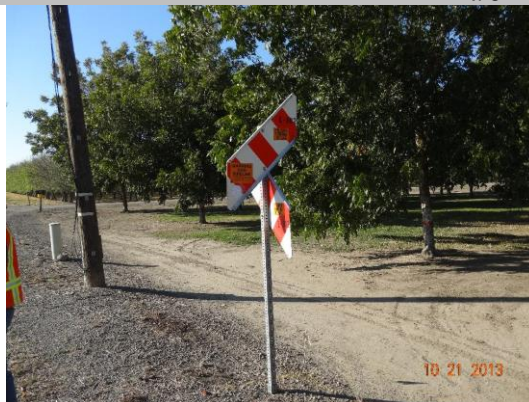
Photo 2 of 3 : UCIP_SP_2018_23384_40247.jpg

Comment Code					
Inspector Comment					
FS_ID:23384 DS_ID:21415 EP_NO: 15936 Repair Type: Non-Urgent Crossing Status: Indicator Found UCIP Comments: No markers visible on levee slope or levee toe to indicate line crosses levee. Need to contact PG&E to confirm location through levee. Also need to confirm the emergency contact person for this crossing. FIELD_STRUCT_DESC: 8-inch steel natural gas pipeline through the levee, 2.5 feet below the crown. Gas line markers on the landside (LS). (Plans to remove an existing 16-inch pipe and install an 8-inch natural gas pipe to existing pipe within the 10-foot LS limits of the levee authorized under Permit No. 15936, 1992 - Pacific Gas and Electric Company [PG&E]). FS Date: 10/21/2013

View of markers on the west side of S. Tarke Road.

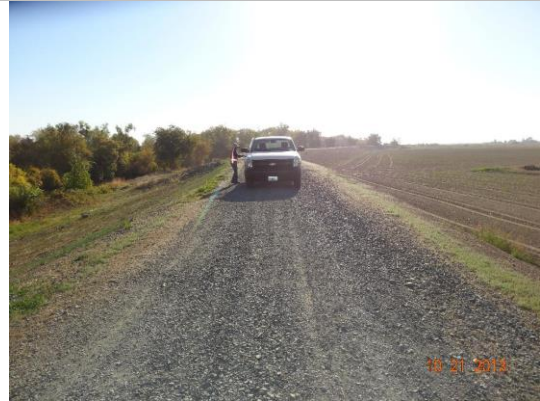
Photo 1 of 3 : UCIP_SP_2018_23503_40784.jpg

Comment Code						
Inspector Comment						
FS_ID:23503						
DS_ID:21351						
EP_NO: 3686						
Repair Type: Non-Urgent						
Crossing Status: Found						
UCIP Comments: Dense vegetation limits the inspector's visibility to identify signs of pipe failure (leaks) along the waterward slope. Recommend removing vegetation along pipe alignment to conduct proper inspection of structure and appurtenances. Unable to find the gate valve on landward side. Walkway on waterward side in bad shape. This crossing is referenced in the USACE Periodic Inspection as item USACE_CESPK_MRD1_2012_p_0300 for 18 inch pipe. Pipe on LS is 10 inch not 18 inch. SEE UCIP DS_ID 21350 for details pertaining to 18 inch pipe.						
FIELD_STRUCT_DESC: 10-inch irrigation discharge pipe of an unknown material through the levee, 14.8 feet below the crown. Electrical conduit through the levee, 1 foot below the crown. Pump on a pile structure in the stream. Service pole with meter and control panel at the landside (LS) toe. Slide gate with walkway on the waterside (WS) end. Gate valve on the LS end, not found during 10/21/2013 pipe inventory. Rock revetment on the WS slope. (Plans for removal of a pump on the LS and installation of a pump and two concrete piers on the WS authorized under Permit No. 3686, 1961 - Gerald A. Frye). [Additional Reference(s): DWR Levee Log, 2007].

View of levee crown looking upstream from crossing.

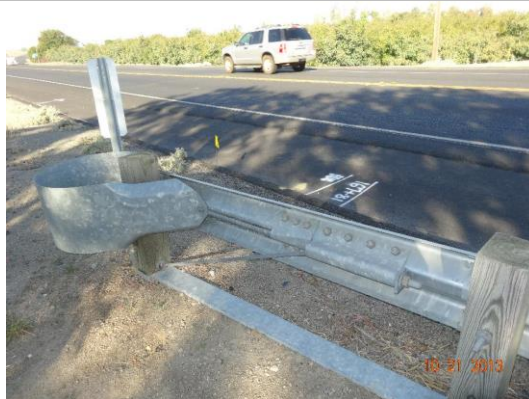
Photo 1 of 3 : UCIP_SP_2018_23467_40643.jpg

FS_ID:23467
DS_ID:21354
EP_NO: 14802
Repair Type: Non-Urgent
Crossing Status: Indicator Found
UCIP Comments: Need to contact owner to determine status of crossing. Need date of last inspection and confirmation that crossing is still in operable condition. Markers found about 159 feet upstream of coordinates at the crossing of the ramp and S. Tarke Road (39.142684, -121.842685).
FIELD_STRUCT_DESC: 4-inch steel natural gas pipeline through the levee, 2.5 feet below the crown. Aluminum pipe marker on the landside (LS) slope. Emergency contact information for Pacific Gas and Electric Company (PG&E): (800) 344-4749? or 4742? or (916) 742-3251. (Plans to replace an existing 3-inch natural gas main through the levee with a new 4-inch steel pipe authorized under Permit No. 14802, 1987 - PG&E). [Additional Reference(s): DWR Levee Log, 2007].
FS Date: 10/21/2013

Underground Service Alert (USA) flag located at the end of Hwy 20 confirming gas line goes through.

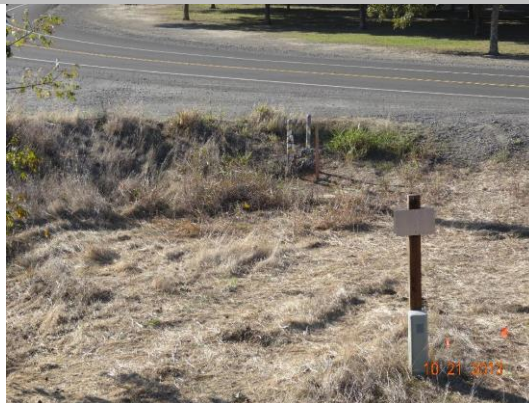
Photo 2 of 3 : UCIP_SP_2018_23467_40641.jpg

Additional appurtenances for gas line located at landward side near S. Tarke Rd.

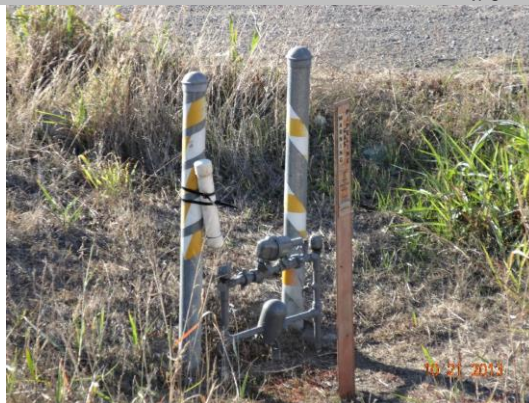
Photo 3 of 3 : UCIP_SP_2018_23467_40640.jpg

Comment Code						
Inspector Comment						
FS_ID:23467 DS_ID:21354 EP_NO: 14802 Repair Type: Non-Urgent Crossing Status: Indicator Found UCIP Comments: Need to contact owner to determine status of crossing. Need date of last inspection and confirmation that crossing is still in operable condition. Markers found about 159 feet upstream of coordinates at the crossing of the ramp and S. Tarke Road (39.142684, -121.842685). FIELD_STRUCT_DESC: 4-inch steel natural gas pipeline through the levee, 2.5 feet below the crown. Aluminum pipe marker on the landside (LS) slope. Emergency contact information for Pacific Gas and Electric Company (PG&E): (800) 344-4749? or 4742? or (916) 742-3251. (Plans to replace an existing 3-inch natural gas main through the levee with a new 4-inch steel pipe authorized under Permit No. 14802, 1987 - PG&E). [Additional Reference(s): DWR Levee Log, 2007]. FS Date: 10/21/2013

Close-up of the additional appurtenances for gas line located landward side.

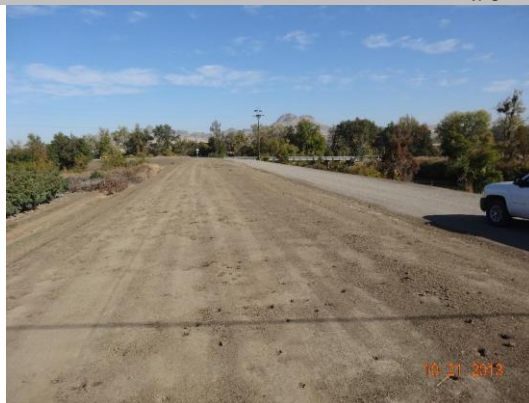
Photo 1 of 3 : UCIP_SP_2018_23526_40942.jpg

Comment Code					
Inspector Comment					
FS_ID:23526 DS_ID:21355 EP_NO: 9961 Repair Type: Non-Urgent Crossing Status: Found UCIP Comments: Dense burrow activity present on both waterward side and landward side. Recommend addressing burrow activity at this location. Also recommend having owner clear vegetation blocking access along walkway. This crossing is referenced in the USACE Periodic Inspection as item USACE_CESPK_MRD1_2012_p_290. FIELD_STRUCT_DESC: 10-inch (not 12-inch as referenced in the permit) steel irrigation discharge pipe through the levee, 5.4 feet below the crown. Siphon breaker in a corrugated metal pipe (CMP) riser on the landside (LS) slope. 24-inch concrete standpipe at the LS toe. Walkway to the pump on a pile structure in the stream. (Retention of a 12-inch steel irrigation pipe through the levee, 5.4 feet below the crown, a walkway to the pump on a pile structure in the stream, and a siphon breaker in a CMP riser on the landward slope authorized under Automatic Board Order (ABO) issued as Permit No. 9961, 1974 - Louis Tarke, Trustee). [Additional Reference(s): DWR Levee Log, 2007]. FS Date: 10/21/2013

View of levee crown and waterward berm looking downstream from crossing.

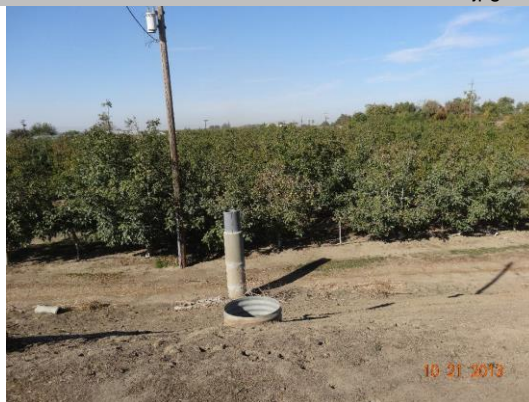
Photo 2 of 3 : UCIP_SP_2018_23526_40941.jpg

View of standpipe and CMP riser located on landward side.

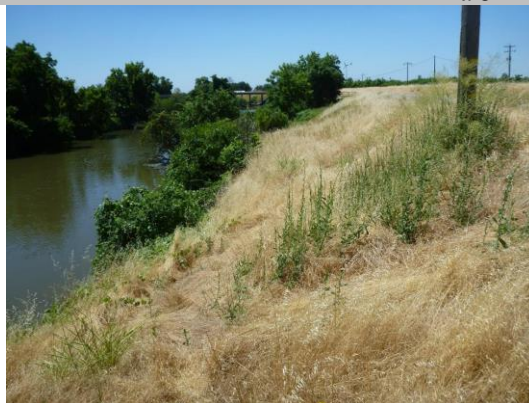
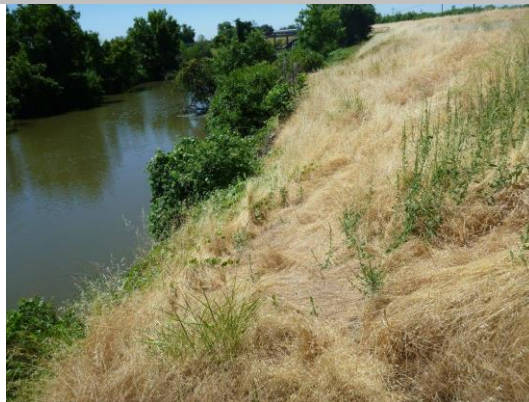
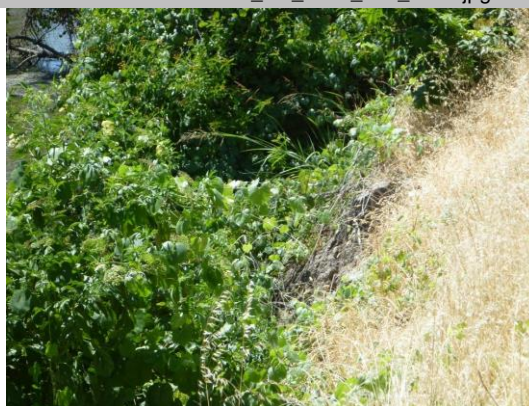
LM Start	0.76	Rating **	A/W	Issue No.	36	
LM End	0.76	Issue Type +	Ma	Location *		
Category	Supplemental			GPS Latitude/Longitude		
				Start		End
Item	2017 Storm Damage			39.145240 °		39.145240 °
				-121.842650 °		-121.842650 °
DWR ID	DWR_RD0070_01_f_2017_36					
Comment Code						
Inspector Comment						
Levee Evaluation Comments						
Description:						
Site ID No:154						
Site Designation:RD 70-03						
Repair Type: Erosion						
Rating:Area of Concern						
Field Date:7/17/2017						
Notes:

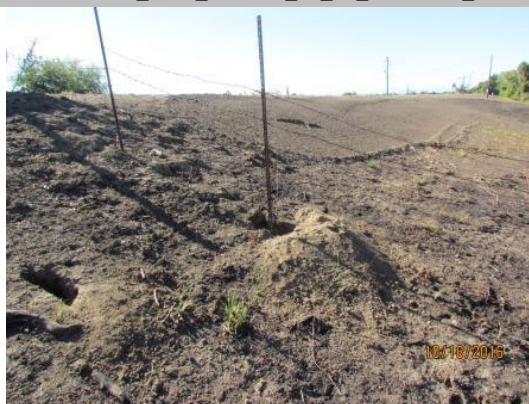
Photo 1 of 1 : SP_2018_RD0070_29_32_20180305_00009.jpg

View of the rodent holes along the waterside slope.

LM Start	1.77	Rating **	M	Issue No.	32
LM End	1.77	Issue Type +	Ma	Location *	LS
Category	Earthen Levee			GPS Latitude/Longitude	
				Start	End
Item	Animal Control			39.151282 °	39.151282 °
				-121.855818 °	-121.855818 °
DWR ID	DWR_RD0070_01_f_2016_32				
Comment Code					
A1 : Exterminate rodents and backfill and compact or grout burrows.					
Inspector Comment

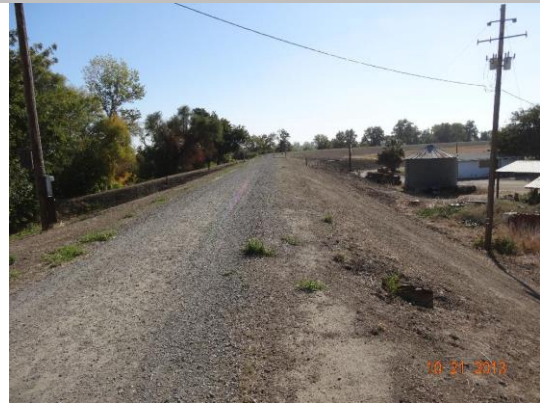
Photo 1 of 3 : UCIP_SP_2018_23508_40821.jpg

FS_ID:23508
DS_ID:21336
EP_NO: N/A
Repair Type: Non-Urgent
Crossing Status: Found
UCIP Comments: Need to find owner to determine if crossing is still in use. If crossing is no longer in use owner will need to coordinate with DWR inspector and CVFPB to remove according to Title 23 requirements. Evidence of high burrow activity on waterward side recommend addressing issue. This crossing is referenced as USACE_CESPK_MRD1_2012_p_0230 in the USACE's PI report for no USACE recommendation letter available -- correction pipe is 12-inch not 16-inch.
FIELD_STRUCT_DESC: 12-inch irrigation discharge pipe of an unknown material through the levee, 4 feet below the crown. Siphon breaker on the landside (LS) slope. 7-foot by 9-foot concrete distribution box at the LS toe. Service pole on the waterside (WS) slope. Pump on a concrete sump on the WS slope. Overhead power line crosses the levee. (Plans for the installation of a 12-inch steel irrigation pipe through the levee authorized under Permit No. 613, 1934 - Waldo M. Nall. Plans to retain a 12-inch pipe through the levee, 4 feet below the crown, pump, and siphon breaker authorized under Automatic Board Order (ABO) issued as Permit No. 9948, 1974 - Edward E. and Doris M. Nall). [Additional Reference(s): DWR Levee Log, 2007].

View of levee crown looking upstream from crossing.

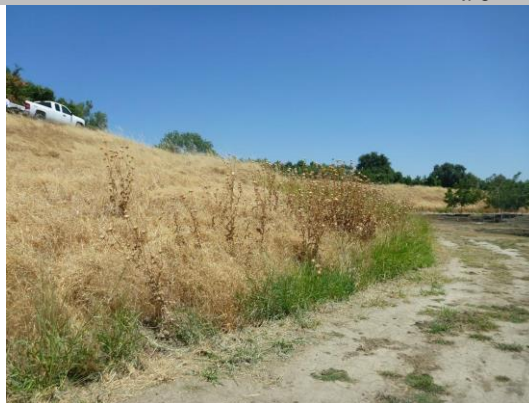
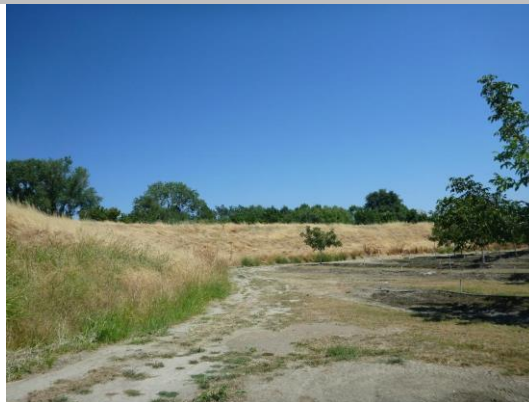
LM Start	3.18	Rating **	A/W	Issue No.	37 (cont)	
LM End	3.18	Issue Type +	Ob	Location *		
Category	Supplemental			GPS Latitude/Longitude		
				Start	End	
Item	2017 Storm Damage			39.157480 °	39.157480 °	
				-121.879250 °	-121.879250 °	
DWR ID	DWR_RD0070_01_f_2017_37					
Comment Code						
Inspector Comment						
Levee Evaluation Comments						
Description:						
Site ID No:153						
Site Designation:RD 70-02						
Repair Type: Seepage (B)						
Rating:Serious						
Field Date:7/17/2017						
Notes:

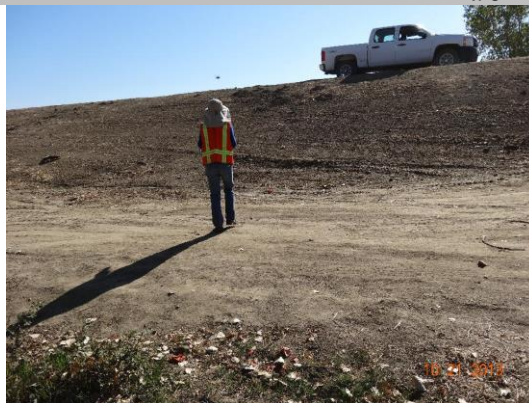
Photo 1 of 3 : UCIP_SP_2018_23506_40806.jpg

FS_ID:23506
DS_ID:21361
EP_NO: 9944
Repair Type: Non-Urgent
Crossing Status: Found
UCIP Comments: Burrow activity present on levee slopes. Multiple pipes found on landward side--are these pipes part of original crossing? This crossing is referenced in the USACE Periodic Inspection as item USACE_CESPK_MRD1_2012_p_0291--no USACE recommendation letter available.
FIELD_STRUCT_DESC: 18-inch steel irrigation discharge pipe through the levee, 21.5 feet below the crown. Gate valve on the waterside (WS) end. Pipe discharges into a concrete box on the landside (LS). Rock revetment on the WS slope. (Retention of an 18-inch steel pipe through the levee, 21.5 feet below the crown, gate valve, and concrete box authorized under Automatic Board Order (ABO) issued as Permit No. 9944, 1974 - William J. and Marion D. Hankins). [Additional Reference(s): DWR Levee Log, 2007].
FS Date: 10/21/2013

View of waterward side slope and berm.

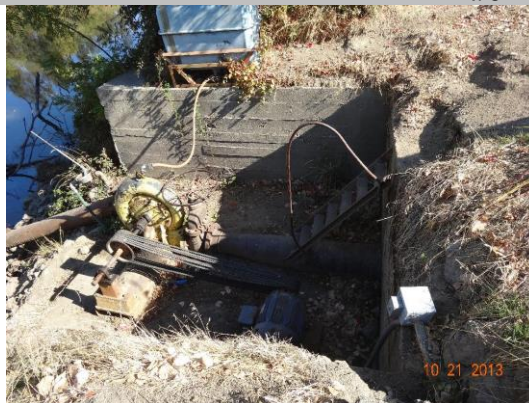
Photo 3 of 3 : UCIP_SP_2018_23506_40807.jpg

Comment Code						
Inspector Comment						
FS_ID:23506 DS_ID:21361 EP_NO: 9944 Repair Type: Non-Urgent Crossing Status: Found UCIP Comments: Burrow activity present on levee slopes. Multiple pipes found on landward side--are these pipes part of original crossing? This crossing is referenced in the USACE Periodic Inspection as item USACE_CESPK_MRD1_2012_p_0291--no USACE recommendation letter available. FIELD_STRUCT_DESC: 18-inch steel irrigation discharge pipe through the levee, 21.5 feet below the crown. Gate valve on the waterside (WS) end. Pipe discharges into a concrete box on the landside (LS). Rock revetment on the WS slope. (Retention of an 18-inch steel pipe through the levee, 21.5 feet below the crown, gate valve, and concrete box authorized under Automatic Board Order (ABO) issued as Permit No. 9944, 1974 - William J. and Marion D. Hankins). [Additional Reference(s): DWR Levee Log, 2007]. FS Date: 10/21/2013

U shaped concrete box located on waterward side contains pump, motor, stairs, and pipe.

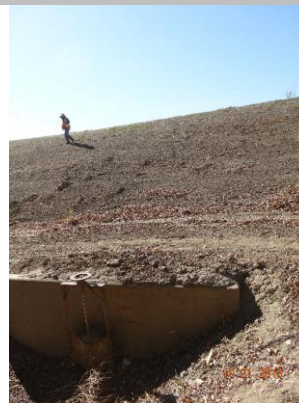
Photo 1 of 3 : UCIP_SP_2018_23510_40837.jpg

Comment Code					
Inspector Comment					
FS_ID:23510 DS_ID:21362 EP_NO: 9944 Repair Type: Non-Urgent Crossing Status: Found UCIP Comments: No pump connection. Need to coordinate with owner to determine status of crossing. If crossing is no longer in use owner will need to contact the CVFPB to comply with Title 23. This crossing is referenced in the USACE Periodic Inspection as item USACE_CESPK_MRD1_2012_p_0183 no USACE recommendation letter available. FIELD_STRUCT_DESC: 18-inch irrigation discharge pipe of an unknown material through the levee, 19.5 feet below the crown. Slide gate on the waterside (WS) end. Pump on the WS. Concrete distribution box on the landside (LS) slope. (Retention of an 18-inch pipe through the levee, 19.5 feet below the crown, and appurtenances authorized under Automatic Board Order (ABO) issued as Permit No. 9944, 1974 - William J. and Marion D. Hankins). [Additional Reference(s): DWR Levee Log, 2007. USACE Sacramento O&M Manual 134, June 1953, (Station 180+50)]. FS Date: 10/21/2013

Concrete head wall and screw gate at waterward toe.

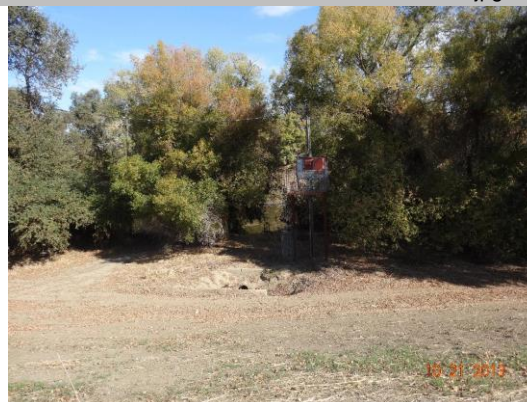
Photo 2 of 3 : UCIP_SP_2018_23510_40838.jpg

View of waterward side.

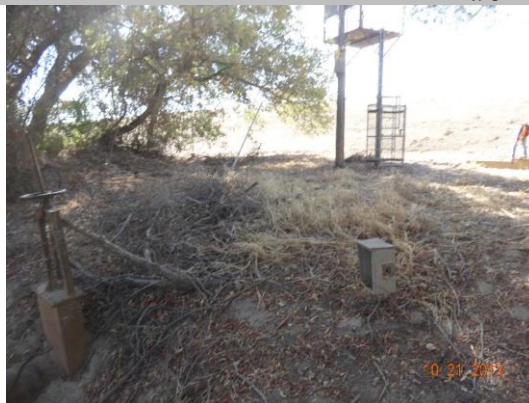
Photo 3 of 3 : UCIP_SP_2018_23510_40836.jpg

Comment Code						
Inspector Comment						
FS_ID:23510 DS_ID:21362 EP_NO: 9944 Repair Type: Non-Urgent Crossing Status: Found UCIP Comments: No pump connection. Need to coordinate with owner to determine status of crossing. If crossing is no longer in use owner will need to contact the CVFPB to comply with Title 23. This crossing is referenced in the USACE Periodic Inspection as item USACE_CESPK_MRD1_2012_p_0183 no USACE recommendation letter available. FIELD_STRUCT_DESC: 18-inch irrigation discharge pipe of an unknown material through the levee, 19.5 feet below the crown. Slide gate on the waterside (WS) end. Pump on the WS. Concrete distribution box on the landside (LS) slope. (Retention of an 18-inch pipe through the levee, 19.5 feet below the crown, and appurtenances authorized under Automatic Board Order (ABO) issued as Permit No. 9944, 1974 - William J. and Marion D. Hankins). [Additional Reference(s): DWR Levee Log, 2007. USACE Sacramento O&M Manual 134, June 1953, (Station 180+50)]. FS Date: 10/21/2013

View of appurtenances located on waterward side.

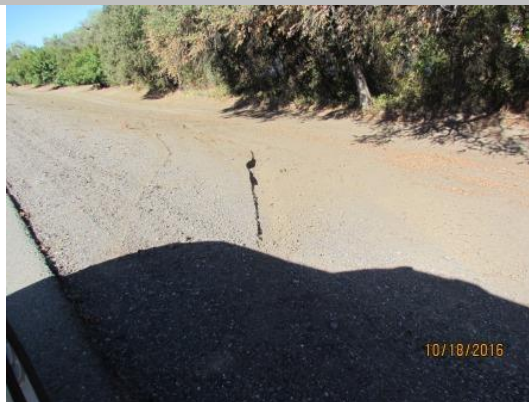
Photo 1 of 1 : SP_2018_RD0070_29_29_20180305_00004.jpg

View of the ruts along the waterside slope.

LM Start	3.72	Rating **	M	Issue No.	29
LM End	3.72	Issue Type +	Ma	Location *	WS
Category	Earthen Levee			GPS Latitude/Longitude	
				Start	End
Item	Slope Stability			39.158183 °	39.158183 °
				-121.888397 °	-121.888397 °
DWR ID	DWR_RD0070_01_f_2016_29				
Comment Code					
S3 : Repair the levee slope damaged by vehicle traffic and prevent access where possible.					
Inspector Comment

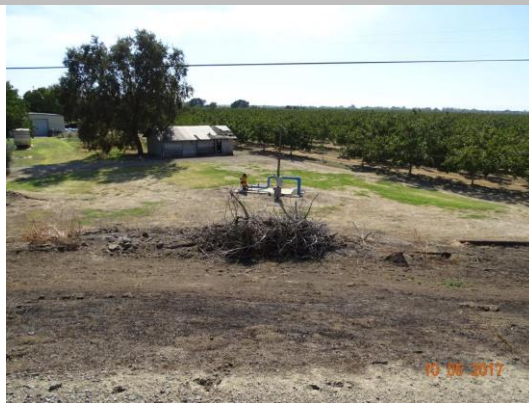
Photo 1 of 1 : SP_2018_RD0070_29_39_20180305_00020.jpg

View of the prunings along the Landside toe.

LM Start	4.15	Rating **	M	Issue No.	39
LM End	4.15	Issue Type +	En	Location *	LS
Category	Earthen Levee			GPS Latitude/Longitude	
				Start	End
Item	Encroachments			39.162757 °	39.162757 °
				-121.893805 °	-121.893805 °
DWR ID	DWR_RD0070_01_f_2017_39				
Comment Code					
PR : Prunings					
Inspector Comment					
Remove the prunings from the landside toe.

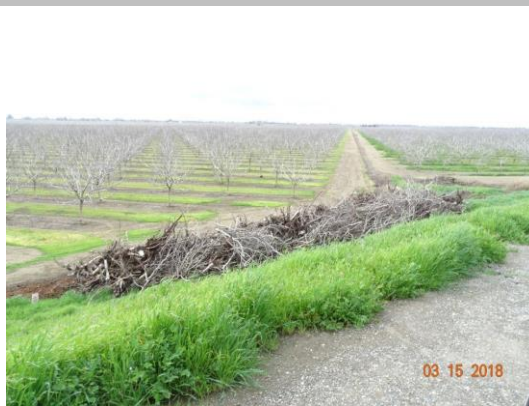
Photo 1 of 1 : SP_2018_RD0070_29_28_20180402_00075.jpg

View of the prunings along the landside toe.

LM Start	4.30	Rating **	M	Issue No.	28
LM End	4.30	Issue Type +	En	Location *	LS
Category	Earthen Levee			GPS Latitude/Longitude	
				Start	End
Item	Encroachments			39.164240 °	39.164240 °
				-121.895758 °	-121.895758 °
DWR ID	DWR_RD0070_01_s_2018_28				
Comment Code					
PR : Prunings					
Inspector Comment					
Remove the prunings from the landside toe.

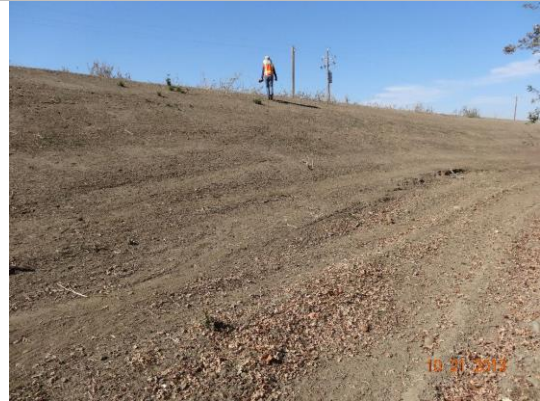
Photo 1 of 3 : UCIP_SP_2018_23515_40867.jpg

Comment Code					
Inspector Comment					
FS_ID:23515 DS_ID:21364 EP_NO: 9954 Repair Type: Non-Urgent Crossing Status: Found UCIP Comments: Power pole down on waterward side. Need to coordinate with owner to determine status of crossing. If crossing is no longer in use owner will need to contact the CVFPB to comply with Title 23. This crossing is referenced in the USACE Periodic Inspection as item USACE_CESPK_MRD1_2012_p_0147. FIELD_STRUCT_DESC: 18-inch (not 24-inch as referenced in the permit) steel irrigation discharge pipe through the levee, 18 feet below the crown. Pipe crosses the levee at a 45 degree angle. Slide gate in a 5-foot by 5-foot concrete box at the waterside (WS) toe. Pump in a pump house on the WS, not found. Discharge box at the landside (LS) toe. Power pole at the WS toe. (Retention of a 24-inch steel pipe through the levee, 18 feet below the crown, pump, slide gate, and discharge box authorized under Automatic Board Order (ABO) issued as Permit No. 9954, 1974 - Parker A. Reische). [Additional Reference(s): DWR Levee Log, 2007]. FS Date: 10/21/2013

View of waterward slope.

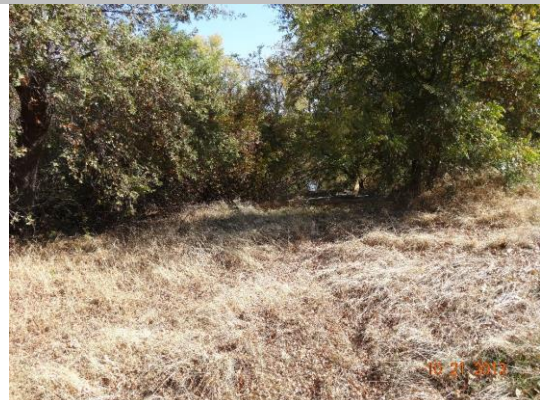
Photo 2 of 3 : UCIP_SP_2018_23515_40868.jpg

View of waterward side.

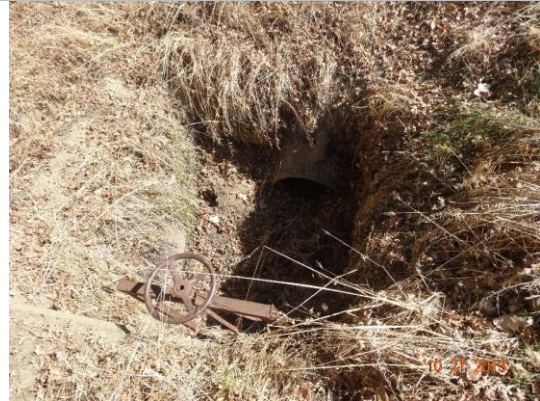
Photo 3 of 3 : UCIP_SP_2018_23515_40869.jpg

Comment Code						
Inspector Comment						
FS_ID:23515 DS_ID:21364 EP_NO: 9954 Repair Type: Non-Urgent Crossing Status: Found UCIP Comments: Power pole down on waterward side. Need to coordinate with owner to determine status of crossing. If crossing is no longer in use owner will need to contact the CVFPB to comply with Title 23. This crossing is referenced in the USACE Periodic Inspection as item USACE_CESPK_MRD1_2012_p_0147. FIELD_STRUCT_DESC: 18-inch (not 24-inch as referenced in the permit) steel irrigation discharge pipe through the levee, 18 feet below the crown. Pipe crosses the levee at a 45 degree angle. Slide gate in a 5-foot by 5-foot concrete box at the waterside (WS) toe. Pump in a pump house on the WS, not found. Discharge box at the landside (LS) toe. Power pole at the WS toe. (Retention of a 24-inch steel pipe through the levee, 18 feet below the crown, pump, slide gate, and discharge box authorized under Automatic Board Order (ABO) issued as Permit No. 9954, 1974 - Parker A. Reische). [Additional Reference(s): DWR Levee Log, 2007]. FS Date: 10/21/2013

View of concrete box located on waterward side, photo 2 of 2.

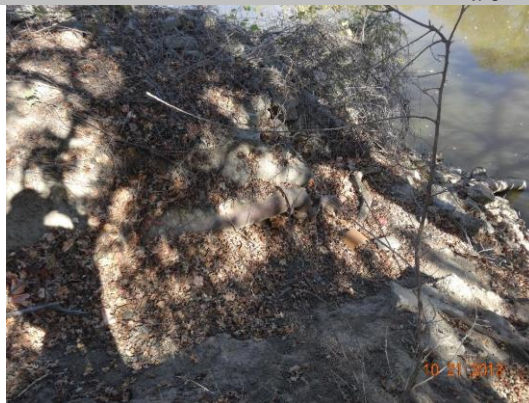
Photo 1 of 3 : UCIP_SP_2018_23516_40873.jpg

Comment Code					
Inspector Comment					
FS_ID:23516 DS_ID:21339 EP_NO: 9951 Repair Type: Non-Urgent Crossing Status: Found UCIP Comments: Need to coordinate with owner to determine status of crossing. If crossing is no longer in use owner will need to contact the CVFPB to comply with Title 23. This crossing is referenced in the USACE Periodic Inspection as item USACE_CESPK_MRD1_2012_p_0144. FIELD_STRUCT_DESC: 10-inch steel irrigation pipe through the levee, 16.3 feet below the crown. Pipe crosses the levee at a 45 degree angle. Siphon breaker in a corrugated metal pipe (CMP) riser on the landside (LS) slope. Gate valve on the waterside (WS) end. Pipe discharges into a concrete discharge box. (Plans to retain a 10-inch steel pipe through the levee, 16.3 feet below the crown, a gate valve, a siphon breaker in a CMP riser, and a concrete discharge box authorized under Automatic Board Order (ABO) issued as Permit No. 9951, 1974 - Frank and Mischa Pirtle). [Additional Reference(s): DWR Levee Log, 2007]. FS Date: 10/21/2013

View of pipe located on waterward side.

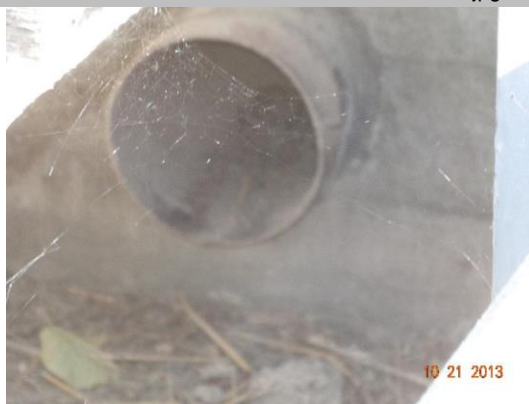
Photo 2 of 3 : UCIP_SP_2018_23516_40872.jpg

View of pipe on landward side inside concrete distribution box.

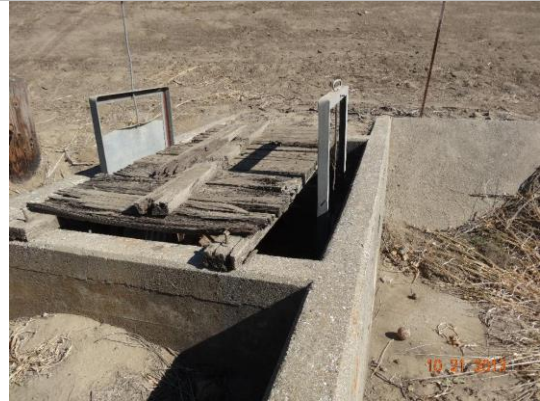
Photo 3 of 3 : UCIP_SP_2018_23516_40874.jpg

Comment Code						
Inspector Comment						
FS_ID:23516 DS_ID:21339 EP_NO: 9951 Repair Type: Non-Urgent Crossing Status: Found UCIP Comments: Need to coordinate with owner to determine status of crossing. If crossing is no longer in use owner will need to contact the CVFPB to comply with Title 23. This crossing is referenced in the USACE Periodic Inspection as item USACE_CESPK_MRD1_2012_p_0144. FIELD_STRUCT_DESC: 10-inch steel irrigation pipe through the levee, 16.3 feet below the crown. Pipe crosses the levee at a 45 degree angle. Siphon breaker in a corrugated metal pipe (CMP) riser on the landside (LS) slope. Gate valve on the waterside (WS) end. Pipe discharges into a concrete discharge box. (Plans to retain a 10-inch steel pipe through the levee, 16.3 feet below the crown, a gate valve, a siphon breaker in a CMP riser, and a concrete discharge box authorized under Automatic Board Order (ABO) issued as Permit No. 9951, 1974 - Frank and Mischa Pirtle). [Additional Reference(s): DWR Levee Log, 2007]. FS Date: 10/21/2013

Concrete distribution box located at landward toe.

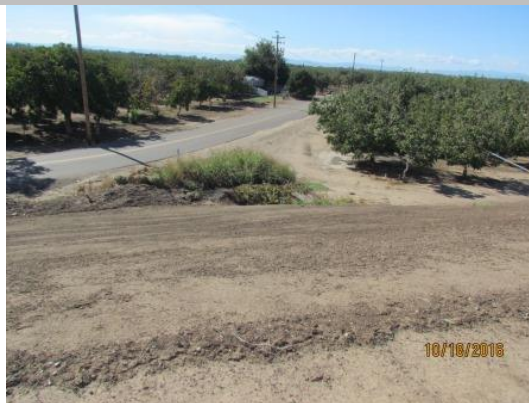
Photo 2 of 2 : SP_2018_RD0070_29_30_20180305_00006.jpg

LM Start	4.65	Rating **	M	Issue No.	30 (cont)	
LM End	4.65	Issue Type +	En	Location *	LS	
Category	Earthen Levee			GPS Latitude/Longitude		
				Start	End	
Item	Encroachments			39.168110 °	39.168110 °	
				-121.899910 °	-121.899910 °	
DWR ID	DWR_RD0070_01_f_2016_30					
Comment Code						
PR : Prunings						
Inspector Comment						
Remove the prunings from the landside slope.

View of the prunings along the landside toe.

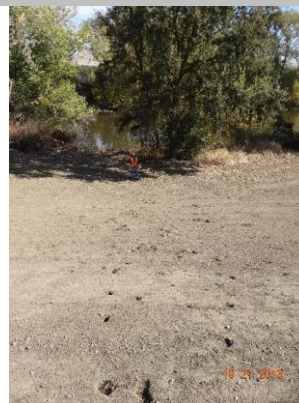
Photo 1 of 3 : UCIP_SP_2018_23517_40883.jpg

Comment Code						
Inspector Comment						
FS_ID:23517 DS_ID:21340 EP_NO: 9954 Repair Type: Non-Urgent Crossing Status: Found UCIP Comments: Burrow activity present on waterward slope. Need to coordinate with owner to determine status of crossing. If crossing is no longer in use owner will need to contact the CVFPB to comply with Title 23. This crossing is referenced in the USACE Periodic Inspection as item USACE_CESPK_MRD1_2012_p_0134. FIELD_STRUCT_DESC: 24-inch corrugated metal irrigation discharge pipe through the levee, 19 feet below the crown. Slide gate on the waterside (WS). Concrete distribution box at the landside (LS) toe. (Retention of a 24-inch corrugated metal pipe (CMP) through the levee, 19 feet below the crown, a slide gate, and a concrete distribution box authorized under Automatic Board Order (ABO) issued as Permit No. 9954, 1974 - Parker A. Reische). [Additional Reference(s): DWR Levee Log, 2007]. FS Date: 10/21/2013

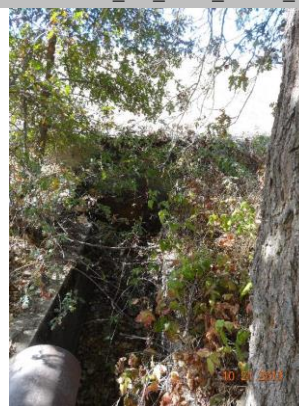
Photo 2 of 3 : UCIP_SP_2018_23517_40877.jpg

Comment Code						
Inspector Comment						
FS_ID:23517 DS_ID:21340 EP_NO: 9954 Repair Type: Non-Urgent Crossing Status: Found UCIP Comments: Burrow activity present on waterward slope. Need to coordinate with owner to determine status of crossing. If crossing is no longer in use owner will need to contact the CVFPB to comply with Title 23. This crossing is referenced in the USACE Periodic Inspection as item USACE_CESPK_MRD1_2012_p_0134. FIELD_STRUCT_DESC: 24-inch corrugated metal irrigation discharge pipe through the levee, 19 feet below the crown. Slide gate on the waterside (WS). Concrete distribution box at the landside (LS) toe. (Retention of a 24-inch corrugated metal pipe (CMP) through the levee, 19 feet below the crown, a slide gate, and a concrete distribution box authorized under Automatic Board Order (ABO) issued as Permit No. 9954, 1974 - Parker A. Reische). [Additional Reference(s): DWR Levee Log, 2007]. FS Date: 10/21/2013

View of pipe located on waterward side.

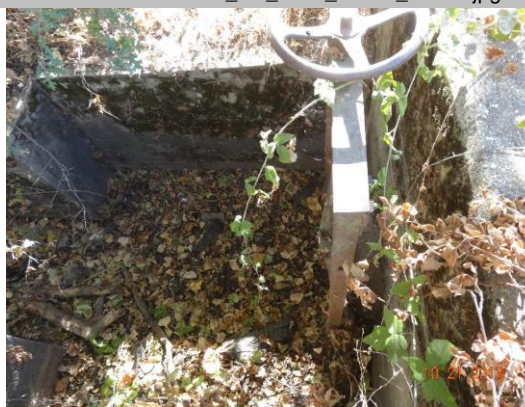
Photo 3 of 3 : UCIP_SP_2018_23517_40882.jpg

View of slide gate on waterward side.

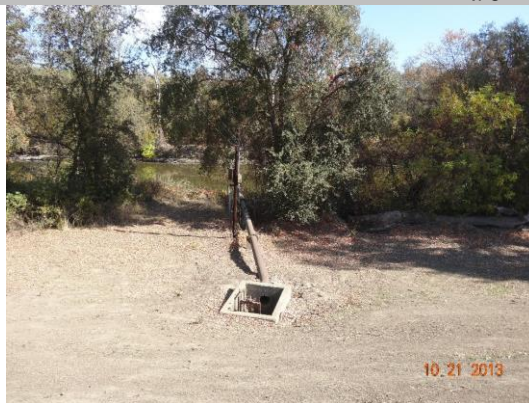
Photo 1 of 3 : UCIP_SP_2018_23518_40886.jpg

View of waterward side--pipe and concrete distribution box.

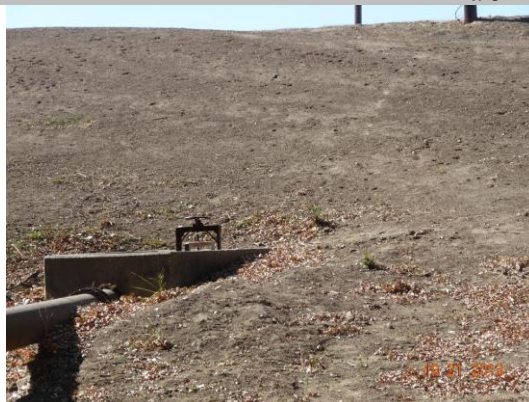
Photo 2 of 3 : UCIP_SP_2018_23518_40887.jpg

View of waterward slope.

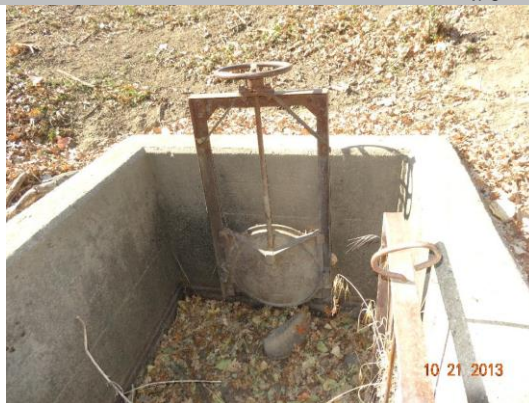
Photo 3 of 3 : UCIP_SP_2018_23518_40890.jpg

Item	DWR UCIP Field Study		39.172334 °	39.172334 °								
			-121.902998 °	-121.902998 °								
DWR ID												
Comment Code												
Inspector Comment												
FS_ID:23518 DS_ID:21338 EP_NO: 9940 Repair Type: Non-Urgent Crossing Status: Found UCIP Comments: No connection present--need to contact owner to determine if owner plans to use. If crossing is no longer in use owner will need to coordinate with DWR inspector and CVFPB to remove according to Title 23 requirements. Unable to determine if crossing is in use. This crossing is referenced in the USACE Periodic Inspection as item USACE_CESPK_MRD1_2012_p_0125. FIELD_STRUCT_DESC: 18-inch steel irrigation discharge pipe through the levee, 19 feet below the crown. Cutoff wall around the pipe at the center of the levee. Slide gate in a concrete distribution box on the landside (LS). Pump on the waterside (WS). Pipe discharges into a concrete box on the LS. (Retention of an 18-inch steel pipe through the levee, 19 feet below the crown, a pump, a slide gate in a concrete distribution box, and a concrete box authorized under Automatic Board Order (ABO) issued as Permit No. 9940, 1974 - Pearl Clark, et al.). [Additional Reference(s): DWR Levee Log, 2007. USACE Sacramento O&M Manual 134, June 1953, (Station 251+30)]. FS Date: 10/21/2013

Screw gate located inside concrete distribution box located on waterward side.

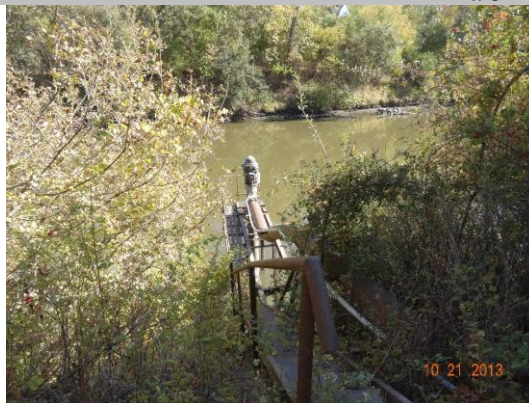
Photo 1 of 3 : UCIP_SP_2018_23519_40896.jpg

Comment Code						
Inspector Comment						
FS_ID:23519 DS_ID:21357 EP_NO: 9957 Repair Type: Non-Urgent Crossing Status: Found UCIP Comments: Burrow activity on slopes -- recommend addressing issue. This crossing is referenced in the USACE Periodic Inspection as item USACE_CESPK_MRD1_2012_p_0110. FIELD_STRUCT_DESC: 12-inch steel irrigation discharge pipe through the levee, 5.5 feet below the crown. Pump on the waterside (WS) slope. Siphon breaker in a corrugated metal pipe (CMP) riser on the landside (LS) slope. Pipe discharges into a concrete box at the LS toe. Service pole at the LS toe. (Plans to retain a 12-inch steel pipe through the levee, 5.5 feet below the crown, a siphon breaker in a CMP riser, a pump, and a concrete box authorized under Automatic Board Order (ABO) issued as Permit No. 9957, 1974 - James E. and Mattie Smith). [Additional Reference(s): DWR Levee Log, 2007]. FS Date: 10/21/2013

View of waterward side--pump, pipe, and walkway.

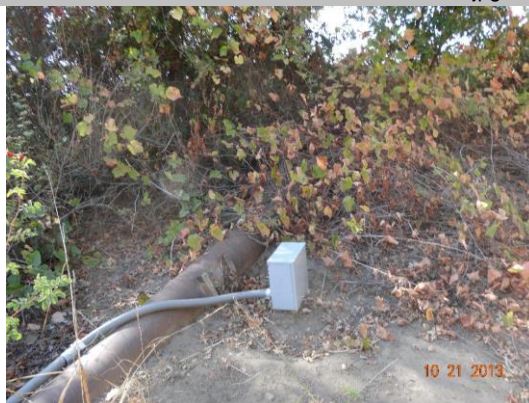
Photo 2 of 3 : UCIP_SP_2018_23519_40898.jpg

Pipe and electrical conduit exposed on levee berm.

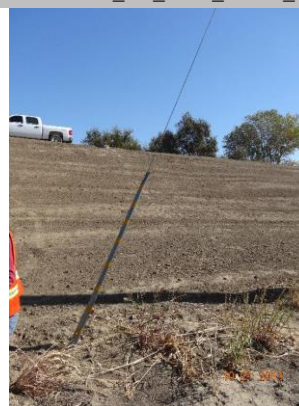
Photo 3 of 3 : UCIP_SP_2018_23519_40897.jpg

Comment Code						
Inspector Comment						
FS_ID:23519 DS_ID:21357 EP_NO: 9957 Repair Type: Non-Urgent Crossing Status: Found UCIP Comments: Burrow activity on slopes -- recommend addressing issue. This crossing is referenced in the USACE Periodic Inspection as item USACE_CESPK_MRD1_2012_p_0110. FIELD_STRUCT_DESC: 12-inch steel irrigation discharge pipe through the levee, 5.5 feet below the crown. Pump on the waterside (WS) slope. Siphon breaker in a corrugated metal pipe (CMP) riser on the landside (LS) slope. Pipe discharges into a concrete box at the LS toe. Service pole at the LS toe. (Plans to retain a 12-inch steel pipe through the levee, 5.5 feet below the crown, a siphon breaker in a CMP riser, a pump, and a concrete box authorized under Automatic Board Order (ABO) issued as Permit No. 9957, 1974 - James E. and Mattie Smith). [Additional Reference(s): DWR Levee Log, 2007]. FS Date: 10/21/2013

View of landward slope.

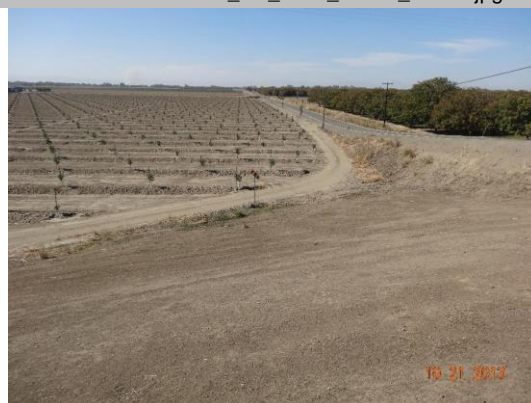
Photo 1 of 3 : UCIP_SP_2018_23479_40724.jpg

FS_ID:23479
DS_ID:21360
EP_NO: 4867
Repair Type: Non-Urgent
Crossing Status: Found
UCIP Comments: Utility marker contact information includes Contact prior to Excavation call 1-800-227-2600 or Emergency Contact 1-800-811-4111. Need to contact owner to determine status of crossing. Need date of last inspection and confirmation that crossing is still in operable condition.
FIELD_STRUCT_DESC: 6.5-inch coated steel natural gas pipeline through the levee, 4 feet below the crown. Concrete cutoff wall around the pipe at the center of the levee. Rock revetment on the waterside (WS) slope. (Plans for installing a gas line through the levee authorized under Permit No. 4867, 1965 - Pacific Gas and Electric Company [PG&E]). [Additional Reference(s): DWR Levee Log, 2007].
FS Date: 10/21/2013

View of landward side.

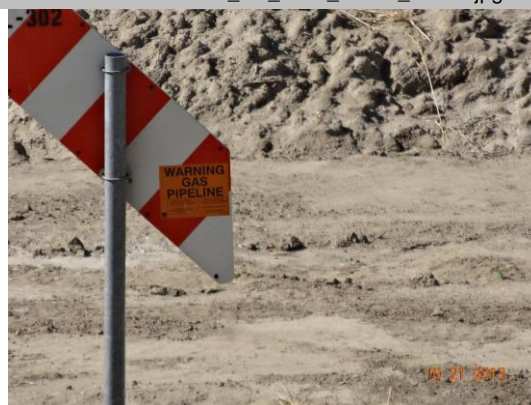
Photo 2 of 3 : UCIP_SP_2018_23479_40723.jpg

Pipeline marker on landward side.

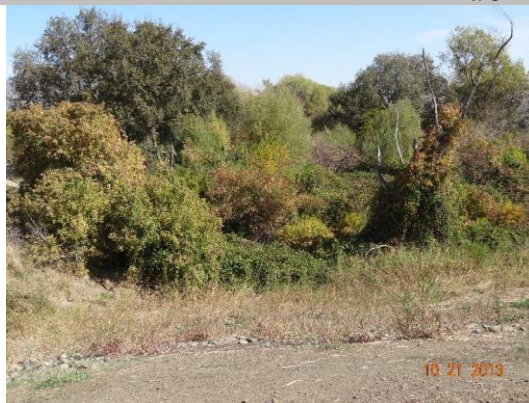
Photo 3 of 3 : UCIP_SP_2018_23479_40722.jpg

Comment Code						
Inspector Comment						
FS_ID:23479						
DS_ID:21360						
EP_NO: 4867						
Repair Type: Non-Urgent						
Crossing Status: Found						
UCIP Comments: Utility marker contact information includes Contact prior to Excavation call 1-800-227-2600 or Emergency Contact 1-800-811-4111. Need to contact owner to determine status of crossing. Need date of last inspection and confirmation that crossing is still in operable condition.						
FIELD_STRUCT_DESC: 6.5-inch coated steel natural gas pipeline through the levee, 4 feet below the crown. Concrete cutoff wall around the pipe at the center of the levee. Rock revetment on the waterside (WS) slope. (Plans for installing a gas line through the levee authorized under Permit No. 4867, 1965 - Pacific Gas and Electric Company [PG&E]). [Additional Reference(s): DWR Levee Log, 2007].						
FS Date: 10/21/2013

View of waterward side.

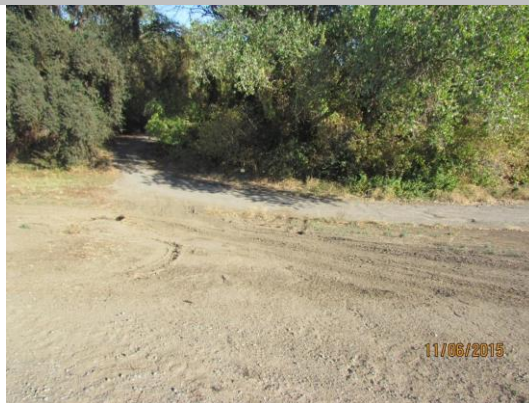
Photo 2 of 2 : SP_2018_RD0070_29_6_20180305_00002.jpg

LM Start	6.18	Rating **	M	Issue No.	6 (cont)	
LM End	6.18	Issue Type +	Ma	Location *	WS	
Category	Earthen Levee			GPS Latitude/Longitude		
				Start		End
Item	Slope Stability			39.187481 °		39.187481 °
				-121.910852 °		-121.910852 °
DWR ID	DWR_RD0070_01_s_2012_6					
Comment Code						
S3 : Repair the levee slope damaged by vehicle traffic and prevent access where possible.						
Inspector Comment

View of the vehicle erosion along the waterside slope.

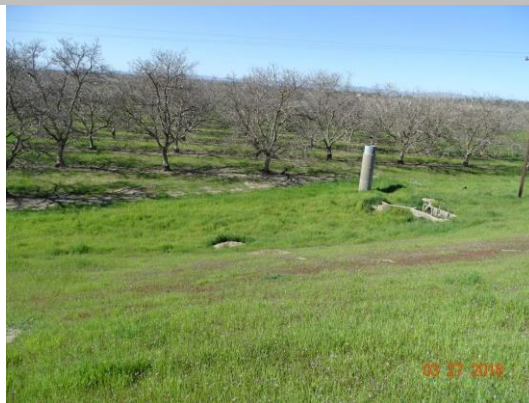
Photo 1 of 1 : SP_2018_RD0070_29_40_20180403_00077.jpg

LM Start	6.57	Rating **	U	Issue No.	40
LM End	6.57	Issue Type +	Ma	Location *	LS
Category	Earthen Levee			GPS Latitude/Longitude	
				Start	End
Item	Animal Control			39.192283 °	39.192283 °
				-121.914388 °	-121.914388 °
DWR ID	DWR_RD0070_01_s_2018_40				
Comment Code					
A3 : No rodents visible, but rodent burrows visible; need to backfill and compact or grout burrows.					
Inspector Comment					
Repair the rodent holes along the landside slope.

View of rodent holes along the landside slope.

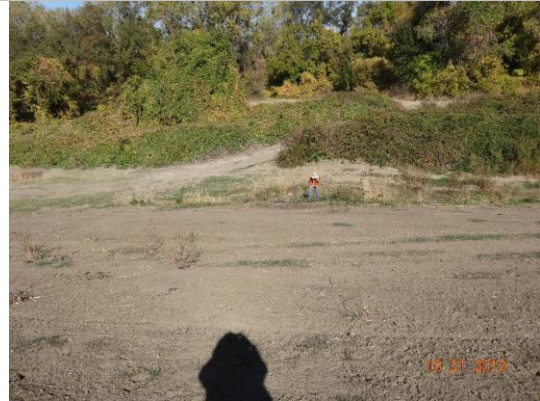
Photo 2 of 3 : UCIP_SP_2018_46422_40914.jpg

Comment Code						
Inspector Comment						
FS_ID:46422 DS_ID:21341 EP_NO: 9960 Repair Type: Non-Urgent Crossing Status: Found UCIP Comments: 07/28/2015 Pipe appears still appears abandoned. Priority was downgraded from Urgent to Non-Urgent due to the inactivity. Need to contact owner to confirm status and future use. If crossing is no longer in use owner will need to coordinate with DWR inspector and CVFPB to remove according to Title 23 requirements.10/21/2013 Hole present on pipe on waterward side. This crossing was determined urgent due to hole on pipe-no signs leaks present on waterward or landward slopes. Unable to find if crossing is being used. Need to contact owner to determine crossing is still in use. If crossing is no longer in use owner will need to coordinate with DWR inspector and CVFPB to remove according to Title 23 requirements. Unable to determine if crossing is in use. This crossing is referenced in the USACE Periodic Inspection as item USACE_CESPK_MRD1_2012_p_0069. FIELD_STRUCT_DESC: 12-inch steel pipe of an unknown purpose through the levee, 6.2 feet below the crown. Siphon breaker in a corrugated metal pipe (CMP) riser on the landside (LS) slope. Service pole on the LS shoulder. Concrete distribution box at the LS toe. (Retention of a 12-inch steel pipe through the levee, 6.2 feet below the crown, a siphon breaker in a CMP riser, a service pole, and a concrete distribution box authorized under Automatic Board Order (ABO) issued as Permit No. 9960, 1974 - Richard L. and Mildred E. Tarke). [Additional Reference(s): DWR Levee Log, 2007. USACE Sacramento O&M Manual 134, June 1953, (Station 332+72)]. FS Date: 7/28/2015 3:30:00 PM

View of waterward side.

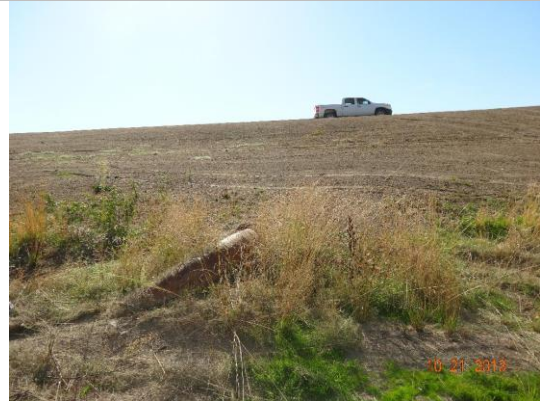
Photo 3 of 3 : UCIP_SP_2018_46422_40913.jpg

Comment Code						
Inspector Comment						
FS_ID:46422 DS_ID:21341 EP_NO: 9960 Repair Type: Non-Urgent Crossing Status: Found UCIP Comments: 07/28/2015 Pipe appears still appears abandoned. Priority was downgraded from Urgent to Non-Urgent due to the inactivity. Need to contact owner to confirm status and future use. If crossing is no longer in use owner will need to coordinate with DWR inspector and CVFPB to remove according to Title 23 requirements.10/21/2013 Hole present on pipe on waterward side. This crossing was determined urgent due to hole on pipe-no signs leaks present on waterward or landward slopes. Unable to find if crossing is being used. Need to contact owner to determine crossing is still in use. If crossing is no longer in use owner will need to coordinate with DWR inspector and CVFPB to remove according to Title 23 requirements. Unable to determine if crossing is in use. This crossing is referenced in the USACE Periodic Inspection as item USACE_CESPK_MRD1_2012_p_0069. FIELD_STRUCT_DESC: 12-inch steel pipe of an unknown purpose through the levee, 6.2 feet below the crown. Siphon breaker in a corrugated metal pipe (CMP) riser on the landside (LS) slope. Service pole on the LS shoulder. Concrete distribution box at the LS toe. (Retention of a 12-inch steel pipe through the levee, 6.2 feet below the crown, a siphon breaker in a CMP riser, a service pole, and a concrete distribution box authorized under Automatic Board Order (ABO) issued as Permit No. 9960, 1974 - Richard L. and Mildred E. Tarke). [Additional Reference(s): DWR Levee Log, 2007. USACE Sacramento O&M Manual 134, June 1953, (Station 332+72)]. FS Date: 7/28/2015 3:30:00 PM

View of waterward slope and pipe at levee toe.

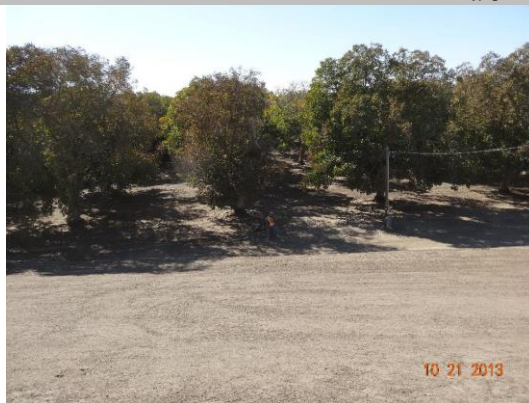
Photo 1 of 2 : UCIP_SP_2018_49188_40922.jpg

FS_ID:49188
DS_ID:21342
EP_NO: N/A
Repair Type: Non-Urgent
Crossing Status: Indicator Found
UCIP Comments: 06/21/2016 This crossing has been modified DWR levee log indicates 12-inch pipe not a 8-inch pipe, unable to determine if pipe goes through levee. This crossing appears to be an irrigation line. Need to find owner to clarify pipe use, determine whether pipe goes through levee, and determine the fate of the original 12-inch pipe through the levee. 10/21/2013 Unable to determine if this is an irrigation pipe or groundwater pipe. This crossing is referenced in the USACE Periodic Inspection as item
USACE_CESPK_MRD1_2012_p_0062--no permit available.
FIELD_STRUCT_DESC: 8-inch (not 12-inch as found in desk study) pipe of an unknown material or purpose through the levee, at an unknown depth. Pump and service pole at the landside (LS) toe.
[Additional Reference(s): DWR Levee Log, 2007].
FS Date: 10/21/2013

View of landward side.

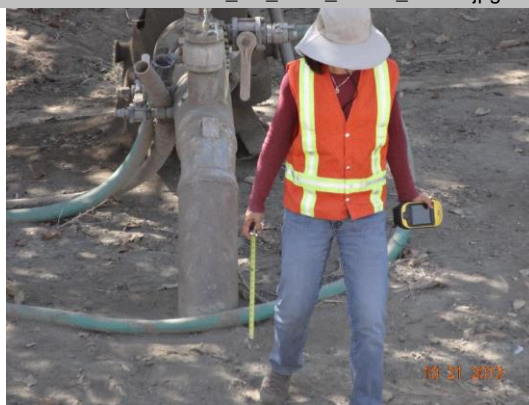
Photo 2 of 2 : UCIP_SP_2018_49188_40921.jpg

Pump system and pipe on landward side.

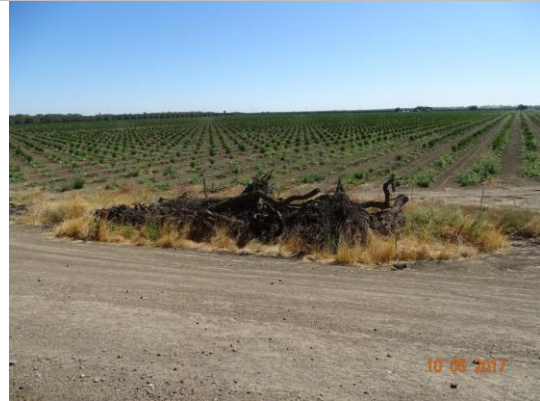
Photo 1 of 1 : SP_2018_RD0070_29_38_20180305_00019.jpg

LM Start	7.54	Rating **	M	Issue No.	38
LM End	7.54	Issue Type +	En	Location *	LS
Category	Earthen Levee			GPS Latitude/Longitude	
				Start	End
Item	Encroachments			39.196665 °	39.196665 °
				-121.929558 °	-121.929558 °
DWR ID	DWR_RD0070_01_f_2017_38				
Comment Code					
TR : Tree or limb					
Inspector Comment					
Remove the tree limbs from the landside toe.

View of the tree limbs along the landside toe.

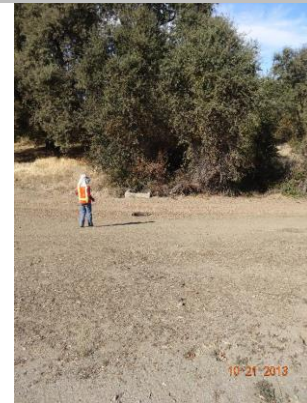
Photo 1 of 3 : UCIP_SP_2018_23529_40964.jpg

Comment Code						
Inspector Comment						
FS_ID:23529 DS_ID:21345 EP_NO: 9942 Repair Type: Non-Urgent Crossing Status: Found UCIP Comments: Dense vegetation limits the inspector's visibility to identify signs of pipe failure (leaks) along the slope. Recommend removing vegetation along pipe alignment to conduct proper inspection of structure and appurtenances. This crossing is referenced in the USACE Periodic Inspection as item USACE_CESPK_MRD1_2012_p_0005. FIELD_STRUCT_DESC: 24-inch corrugated metal irrigation discharge pipe through the levee, 16.5 feet below the crown. Incline pump on the waterside (WS). Slide gate in a corrugated metal pipe (CMP) riser on the WS slope. Pipe discharges into a concrete box at the landside (LS) toe. Service pole on the LS. (Retention of a 24-inch CMP through the levee, 16.5 feet below the crown, a slant pump, a slide gate in a CMP riser, a box, and a service pole authorized under Automatic Board Order (ABO) issued as Permit No. 9942, 1974 - R. W. and H. Evelyn Draper). [Additional Reference(s): DWR Levee Log, 2007. USACE Sacramento O&M Manual 134, June 1953, (Station 330+00)]. FS Date: 10/21/2013

View of waterward slope.

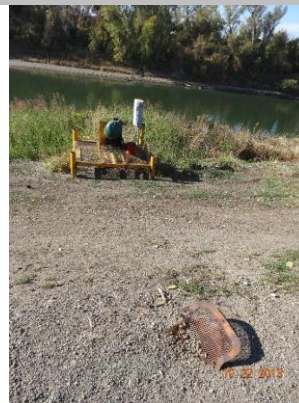
Photo 1 of 3 : UCIP_SP_2018_52618_42061.jpg

FS_ID:52618
DS_ID:21382
EP_NO: 12707
Repair Type: Urgent
Crossing Status: Found
UCIP Comments: 05/16/2018 2-foot round depression on waterward side found 4.5' from levee crown (Marty Rd). 14'x8'x3' excavation found on waterside slope to expose 14"-pipe. Evidence of internal erosion found at the bottom of excavation toward the pump. Cracks in asphalt pavement on levee crown (DWR UCIP - O.Yakimov)
11/03/2017 Crossing failed on WS and section of the levee was exposed to determine the extend of pipe damage by owner. Pipe is an up and over crossing. Crossing has been upgraded from Non-Urgent to Urgent due to pipe failure and exposed section of the levee visible on WS. (DWR UCIP - O. Magana)10/22/2013 Burrow activity noticed at this location. Crossing appurtenances have been modified. No 36-inch concrete distribution stand pipe present instead there is a concrete distribution box located at the landward toe. Also siphon breaker housing unit damage. Will need to contact owner. Need to obtain maintenance records and clarify modifications made at to crossing. Recommend having owner clear vegetation on waterward side. This crossing is referenced in the USACE Periodic Inspection as item USACE_CESPK_MRD2_2012_p_0018.

View of waterward side--siphon breaker housing unit, pipe daylight, pump, and plateform.

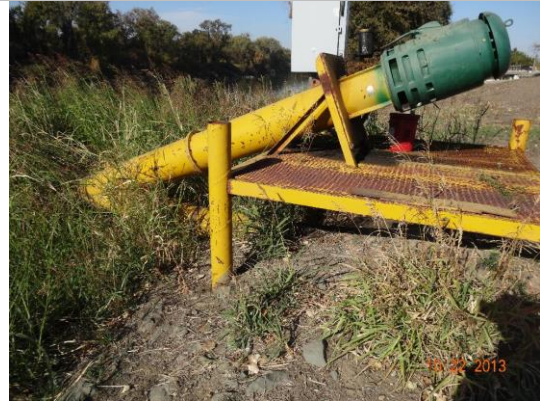
Photo 2 of 3 : UCIP_SP_2018_52618_42060.jpg

FS_ID:52618
 DS_ID:21382
 EP_NO: 12707
 Repair Type: Urgent
 Crossing Status: Found
 UCIP Comments: 05/16/2018 2-foot round depression on waterward side found 4.5' from levee crown (Marty Rd). 14'x8'x3' excavation found on waterside slope to expose 14"-pipe. Evidence of internal erosion found at the bottom of excavation toward the pump. Cracks in asphalt pavement on levee crown (DWR UCIP - O.Yakimov)
 11/03/2017 Crossing failed on WS and section of the levee was exposed to determine the extend of pipe damage by owner. Pipe is an up and over crossing. Crossing has been upgraded from Non-Urgent to Urgent due to pipe failure and exposed section of the levee visible on WS. (DWR UCIP - O. Magana)10/22/2013 Burrow activity noticed at this location. Crossing appurtenances have been modified. No 36-inch concrete distribution stand pipe present instead there is a concrete distribution box located at the landward toe. Also siphon breaker housing unit damage. Will need to contact owner. Need to obtain maintenance records and clarify modifications made at to crossing. Recommend having owner clear vegetation on waterward side. This crossing is referenced in the USACE Periodic Inspection as item USACE_CESPK_MRD2_2012_p_0018.

View of pump on waterward side.
